### **Report of Findings**

STRUCTURAL EVALUATION Claim No: 1002259499

RCG File No: 22804649

CSAA INSURANCE COMPANY 3100 QUAIL SPRINGS PARKWAY OKLAHOMA CITY, OK 73134

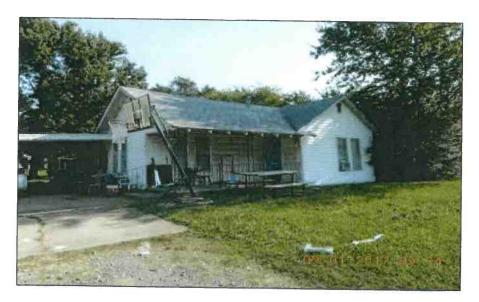
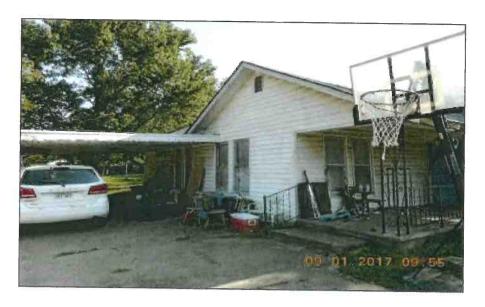
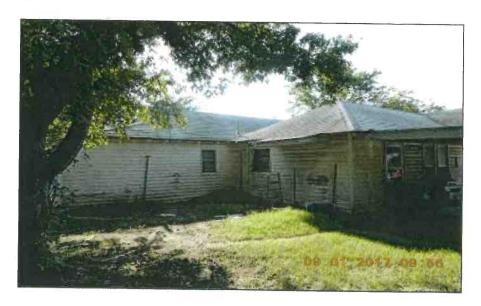
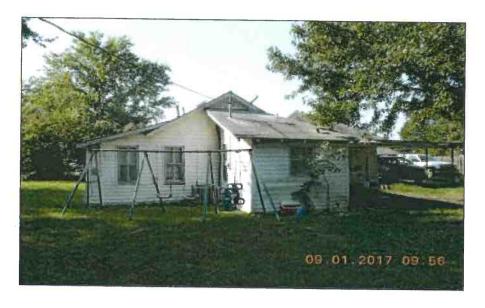
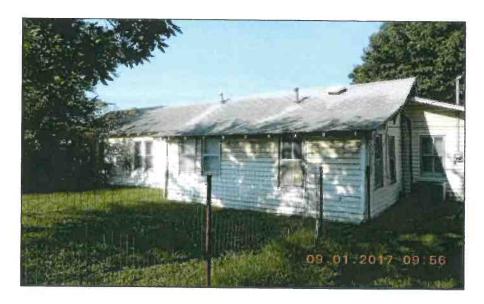
The residential property was a one-story, wood-framed dwelling covered with vinyl siding on the exterior. The foundation was a combination shallow foundation perimeter walls of an unknown material with portions of concrete slab foundation added later. The interior wall finishes were a combination of lath and plaster and drywall with paint. The ceiling was furring strips with acoustical ceiling tiles. The flooring was a combination of carpet and vinyl flooring. The roof covering was asphalt shingles. For the purposes of this report, the side of the residence with the front entrance door faces south, refer to (**Photographs 1 through 5**).

Photograph 1 South side.

Photograph 2
Front east side.

Photograph 3
Rear east side.

Photograph 4 North side.

Photograph 5 West side.

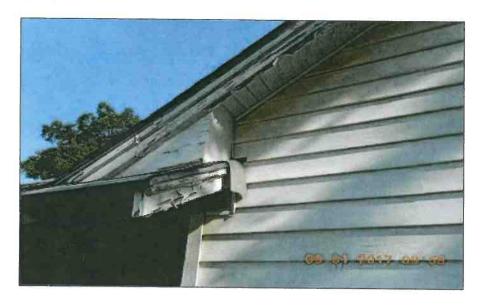
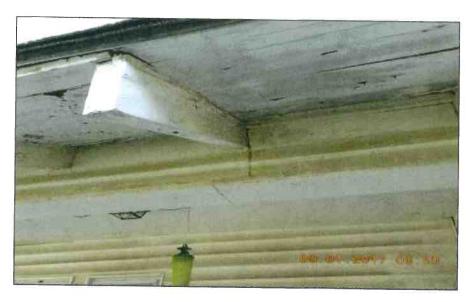
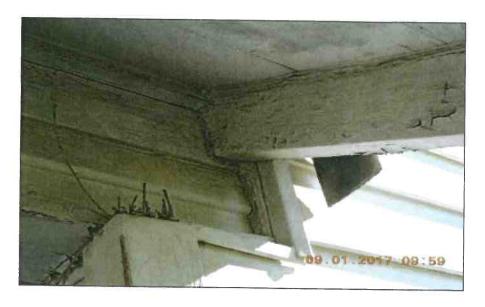
• The roof rafter connections to the wall framing were observed to be intact and

without separation. Roof framing locations that did have cracks or

separations were observed to have dust and cobwebs within the separations

(Photographs 6 through 8).

Photograph 6
Roof connection.

Photograph 7
Roof connection.

Photograph 8
Roof connection.

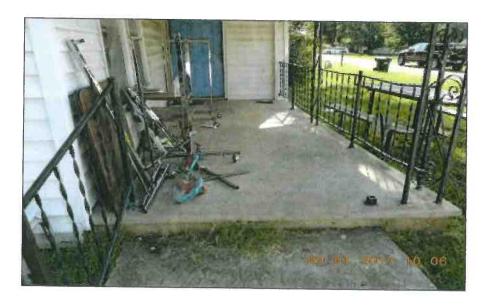
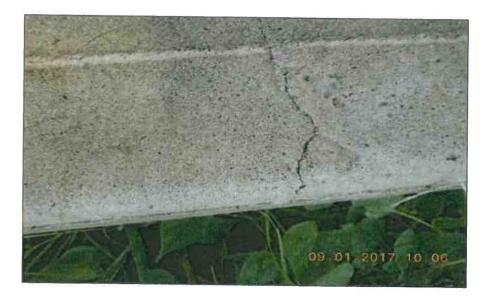
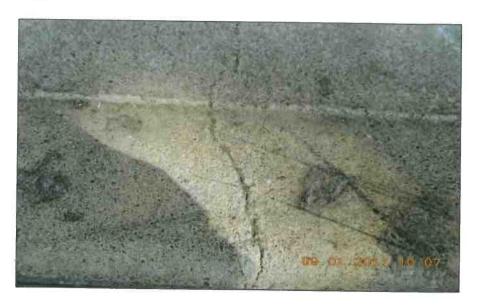
The slab supporting the front porch contained cracks. The stem wall was

covered by the vinyl siding (Photographs 9 through 11).

Photograph 9
Front porch.

Photograph 10
Front porch crack.

Photograph 11
Front porch crack.

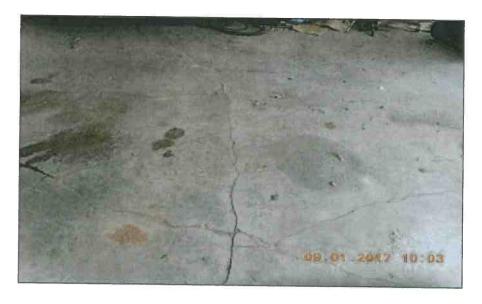
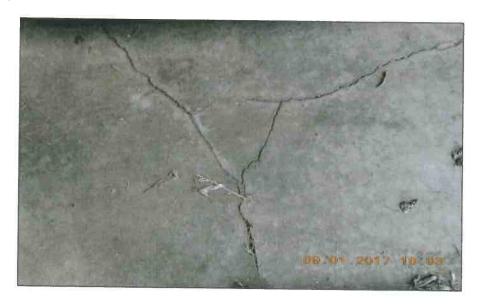
Cracks existed in the driveway slab under the carport. The cracks contained

dust and showed wear over time along the edges of the cracks.

(Photographs 12 through 14).

The origin of the damage observed to the floor, ceiling tiles, and driveway slab under the carport was from differential foundation movement related to volumetric soil changes from soil moisture variations over time. This is shown by the floor elevations that demonstrate variation in ground movement over an extended period of time. Poor construction techniques found at the foundation contributed.

Photograph 12 Driveway crack.

Photograph 13 Driveway crack.

Photograph 14 Driveway crack.

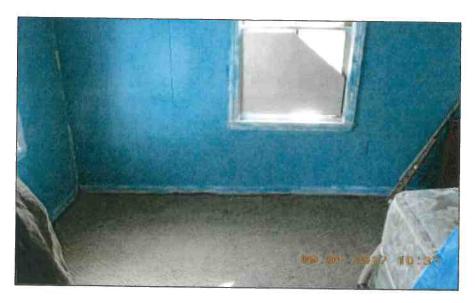
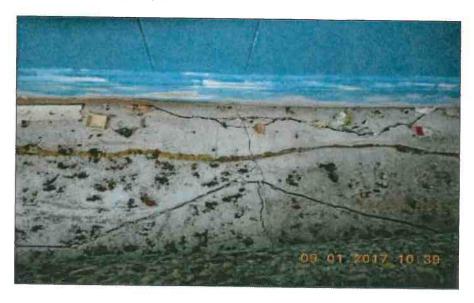
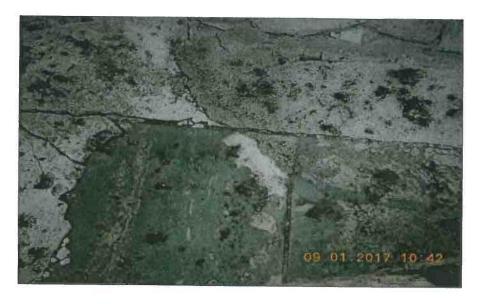
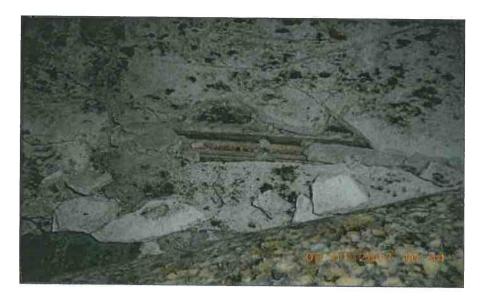
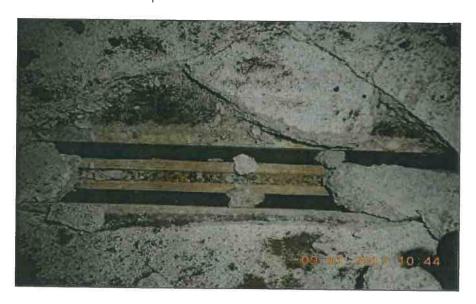
• The carpet was pulled back in the son's bedroom, and the concrete under the

carpet was examined. The concrete had an area where it had been patched.

It was cracked and broken. Examining below the broken pieces of concrete,

it was determined that the room was extended at some point and a new strip

footing had been added, and there was plywood incorporated in the footing.

(Photographs 15 through 19).

The uneven floor was determined to be caused by differential foundation movement. The crack along the wall and leaning wall were determined to be caused by a poorly constructed floor extension consisting of an added footing adjacent to an interior slab. Other interior cracks showed signs of age and contained no stretched or cracked paint. The residence was out of plumb in several locations with the cause being differential foundation movement. Horizontal cracks were observed in the driveway slab and the front porch. These cracks showed signs of age and were consistent with shrinkage cracks and differential foundation movement cracks. Furthermore, cobwebs and insect nests were observed in several of the separations indicating they were not recently formed.

Photograph 15 Son's room.

Photograph 16
Son's room floor under the carpet.

Photograph 17 Son's room floor under the carpet.

Photograph 18 Son's room floor under the carpet.

Photograph 19
Son's room floor under the carpet.

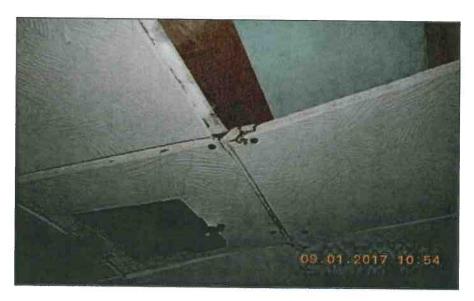
It was observed that the ceiling in the bathroom and son's bedroom had ceiling tiles that were missing. Repairs of these tiles were observed to be

aged (Photograph 20).

Photograph 20 Ceiling tiles.
